GOVERNMENT OF PAKISTAN
MINISTRY OF PETROLEUM & NATURAL RESOURCES
GEOLOGICAL SURVEY OF PAKISTAN

REPORT FOR NATIONAL DISASTER MANAGEMENT AUTHORITY

CAUSATIVE MECHANISMS
OF TERRAIN MOVEMENT IN HUNZA VALLEY

by
S. HAMID HUSSAIN
ADNAN ALAM AWAN
ENVIRONMENTAL AND ENGINEERING GEOLOGY DIVISION

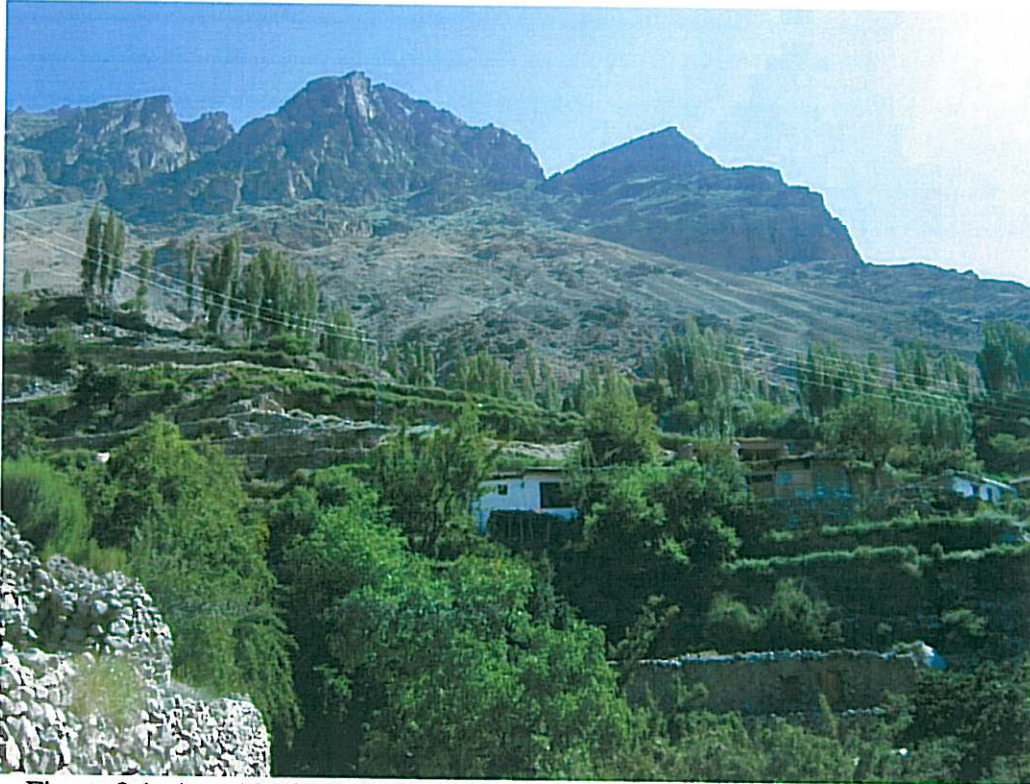
3. High slope angle is a major triggering factor for eastern Atta Abad (Fig 3.1). Slope angle at terraces is ranging from 30° to 40° , at backslopes from 35° to 55° and toe of terraces is near to vertical.

Figure 3.1: Atta Abad at direct hit from boulders lying at high angle backslope

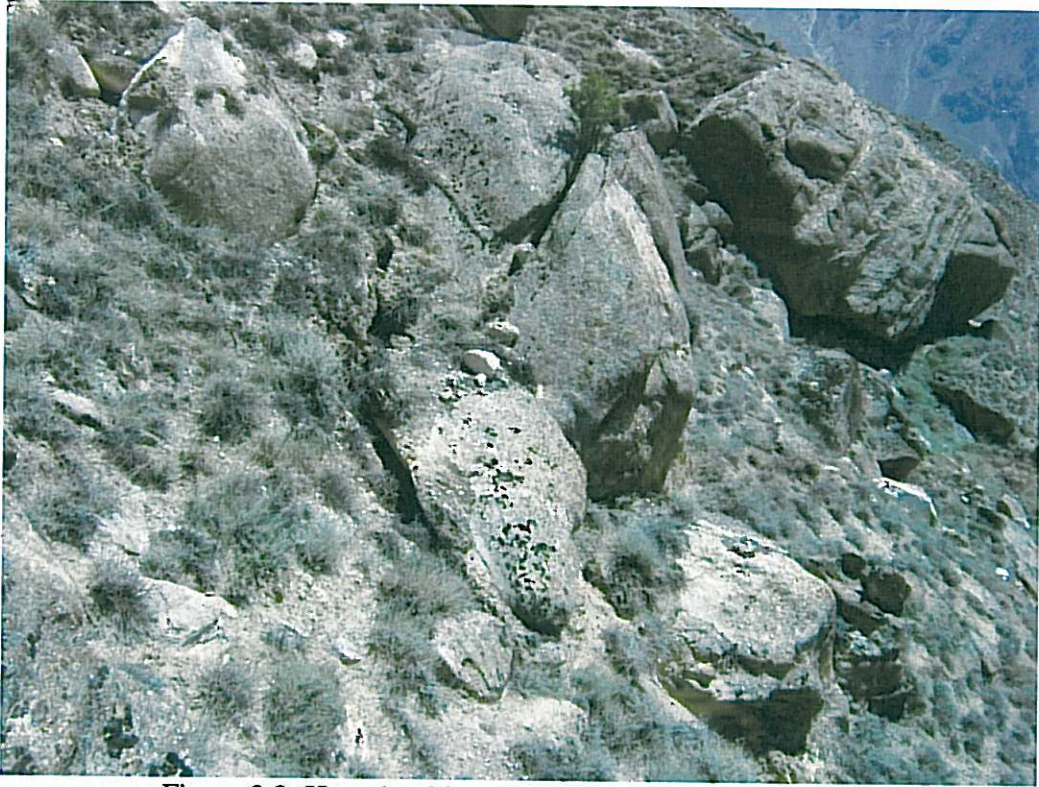
Figure 3.2: Huge boulders loosely lying on the baskslope

2. The boulders loosely lying on the backslope (Fig 3.2) should be safely brought down using the techniques of control blasting.
3. Poor drainage in the terraces should be managed into proper drainage and water should be diverted from infiltrating into cracks and loose overburden.

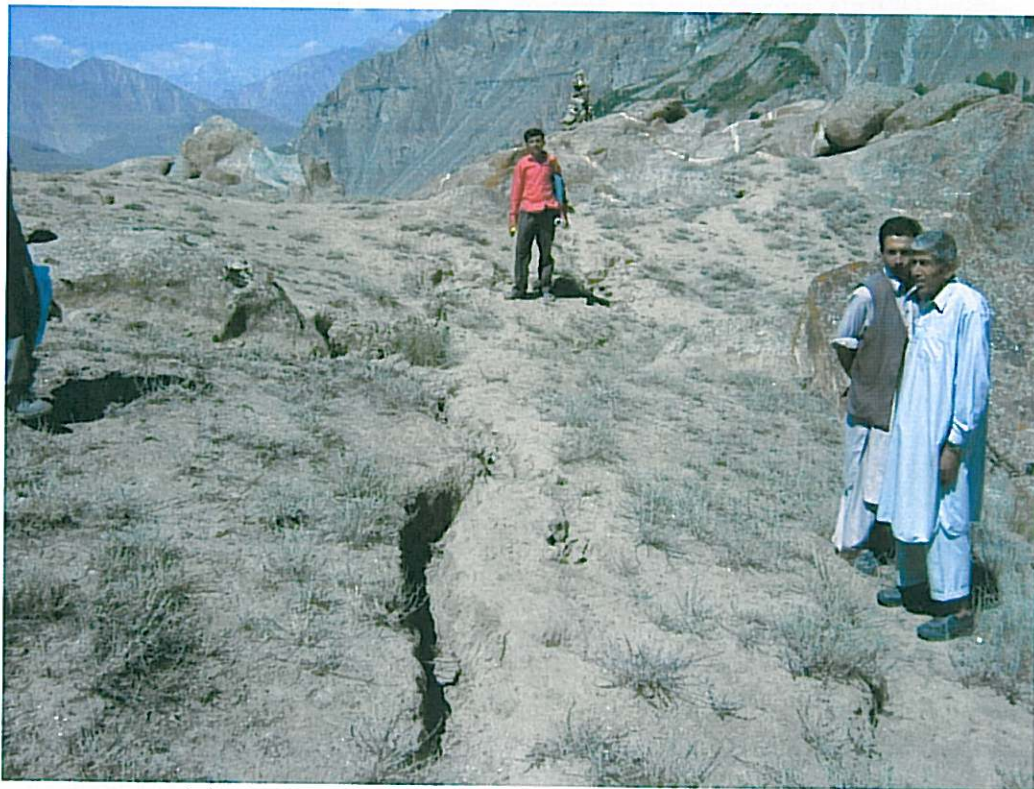
Figure 3.3: Crack widening at the left margin of upper slope

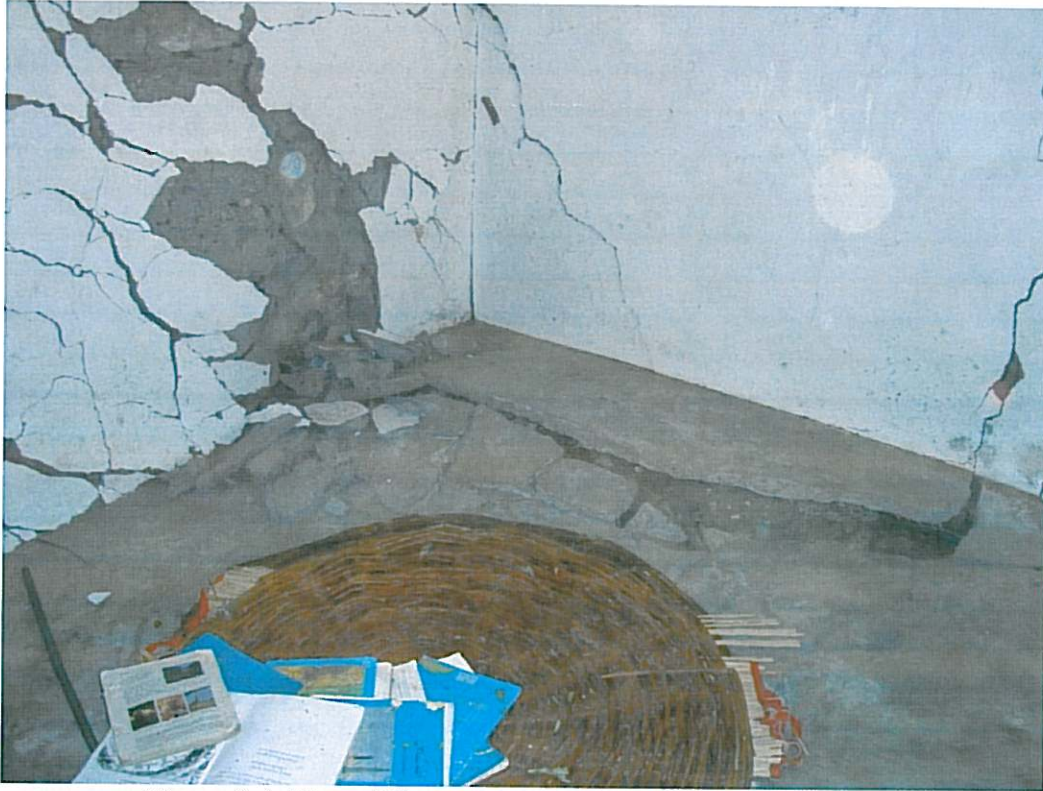
The network of cracks and fissures present in the area are the potential source of any future calamity and may result into loss of life and property. Three major networks of cracks (Fig 4.1) have been identified on the backslopes and one pattern of cracks has been observed at the terraces (Fig 3.4).

Figure 3.4: Slope failure at terraces have damaged the house

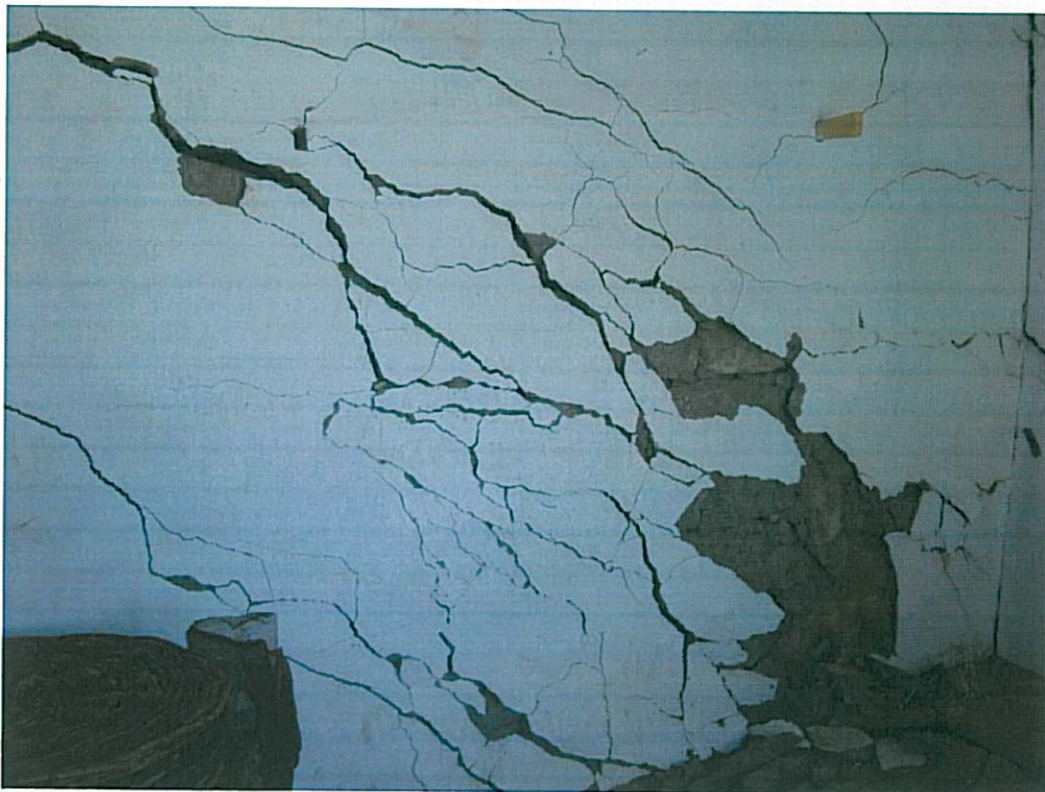
Figure 3.5: House damaged due to cracks on terraces

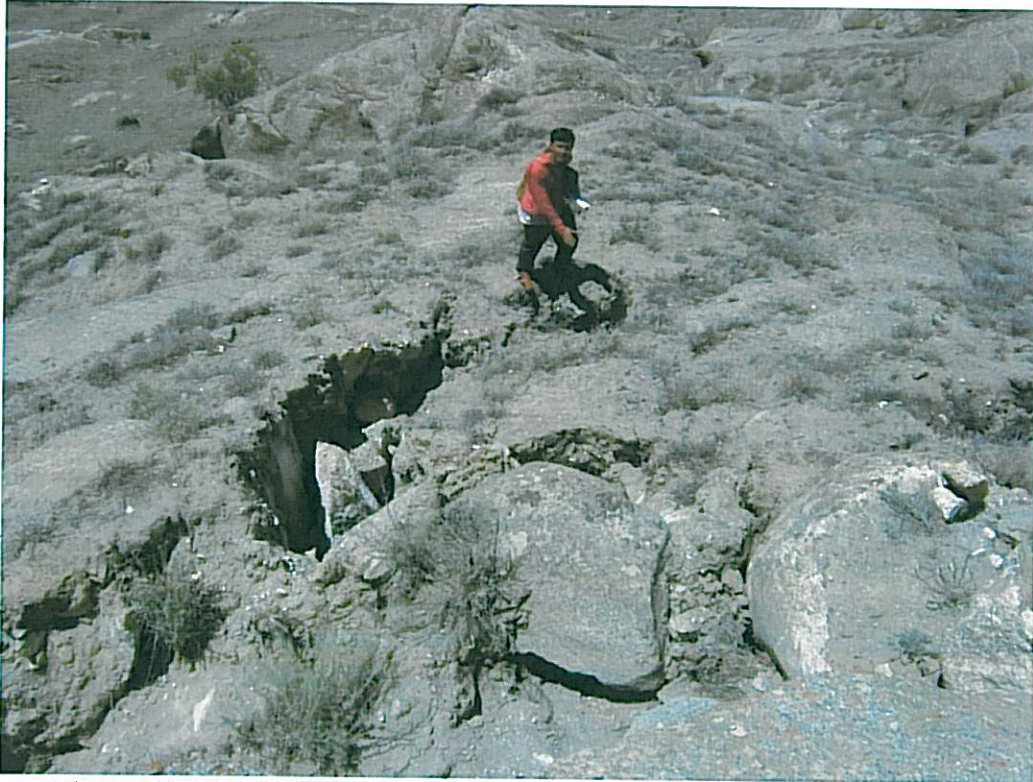
Figure 3.6: Very wide cracks posing a potential risk for Atta Abad village

4. It is not possible to fill all the cracks present in the area but nevertheless an effort should be made to fill and seal some cracks using the plastic sheets, starting from the terraces and moving upward into the backslopes. It will help to decrease the slope failure to some extent in the areas where the slip circle is not deep.

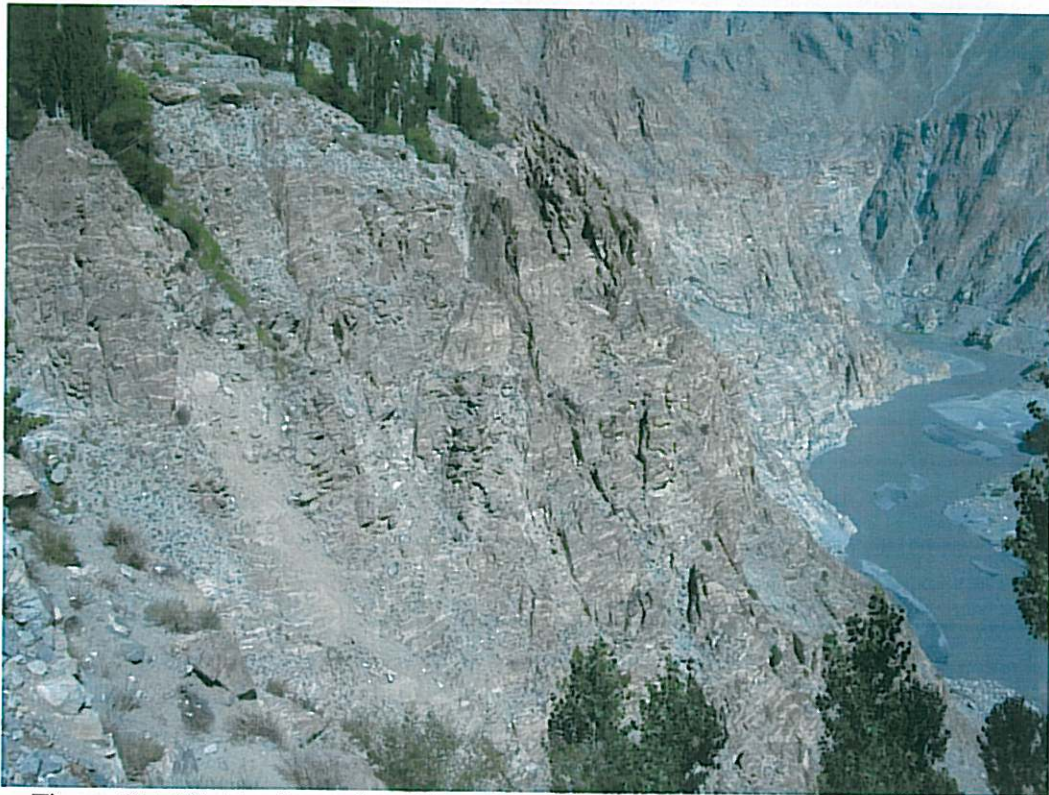
Figure 3.7: Highly sheared and fractured bedrock forming the toe of Atta Abad

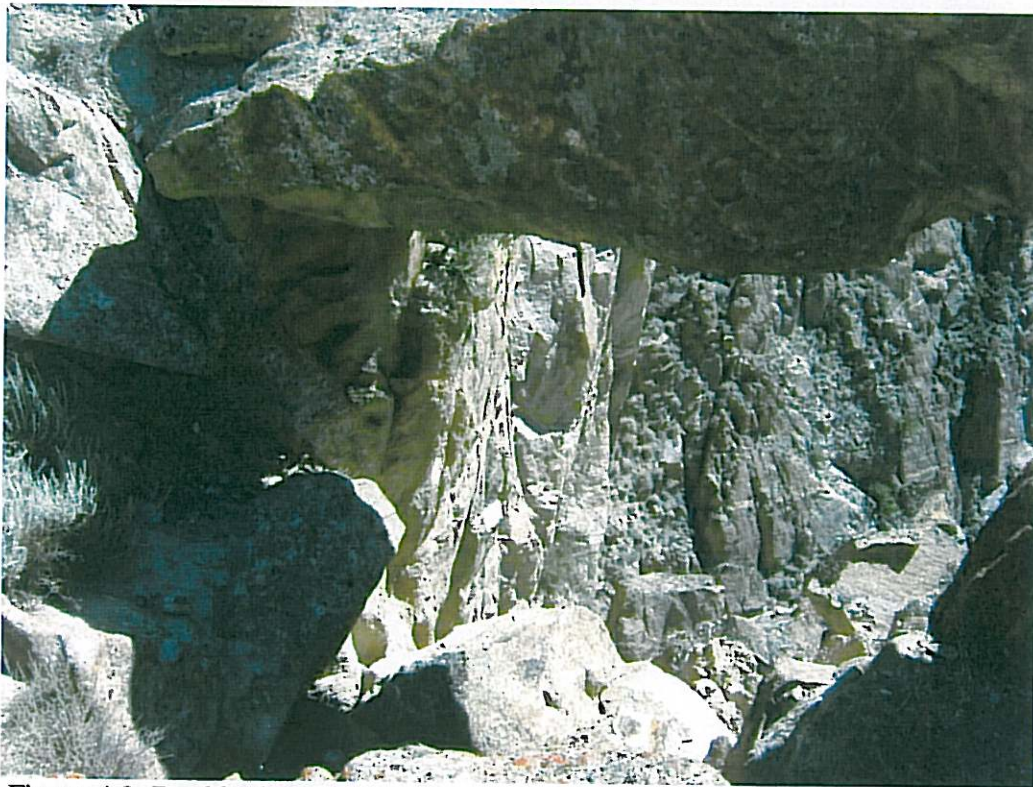
Figure 4.2: Boulder hanging dangerously on the widened crack at eastern margins

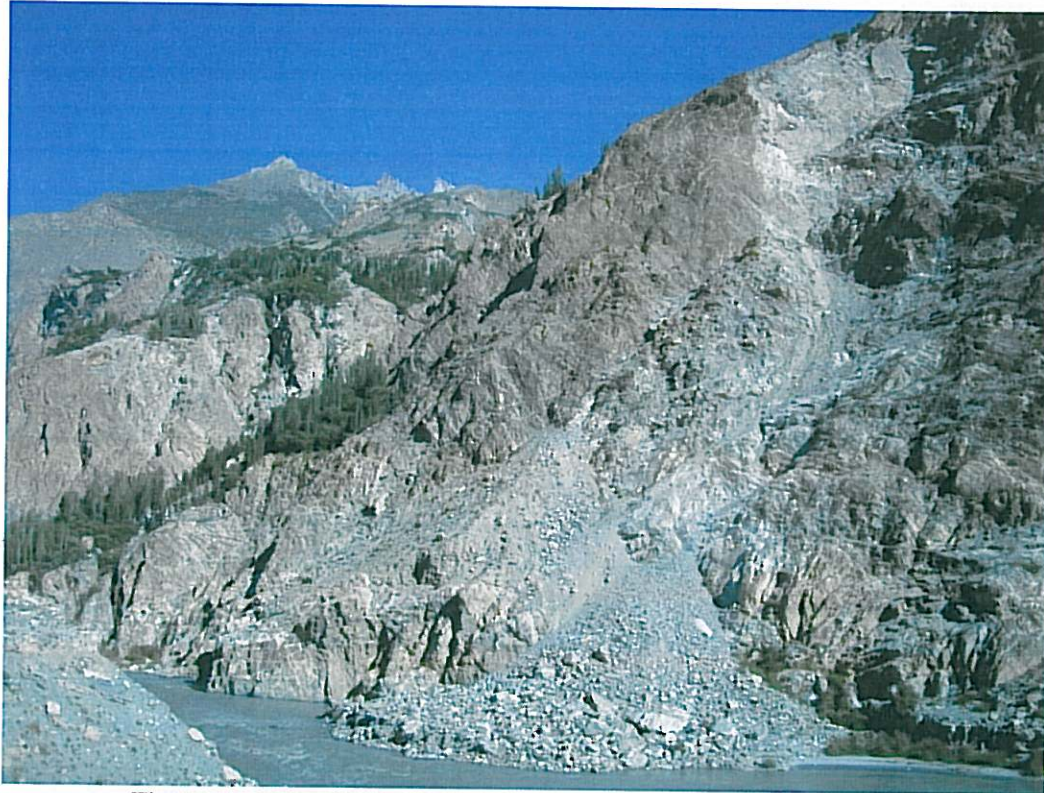
The area is at threat from multi directions. On one side huge boulders of room size (12x16x22 ft) are lying loosely at the backslops (Fig 4.1) and most of them have moved from their original location because of the slope condition, any movement in the slope or an earthquake of magnitude of 4.5 or greater on Ritcher Scale may roll down the boulders and hit the population. The toe of terraces is creeping and displacements of terraces are the result of this weak toe because the rocks are highly sheared, fractured and jointed (Fig 3.7). This part has a potential to slide down in the form of a rock avalanche and block the river. During investigation geological evidence of same kind of threatened river blockage has been identified at 1.2 km downstream at village Sarat (Fig 4.6). A landslide is present at the eastern margins of the area and material is falling into the river and it is further enhancing the triggering factors in the area (Fig 4.3).

Figure 4.3: Active landslide at the eastern margin of Atta Abad

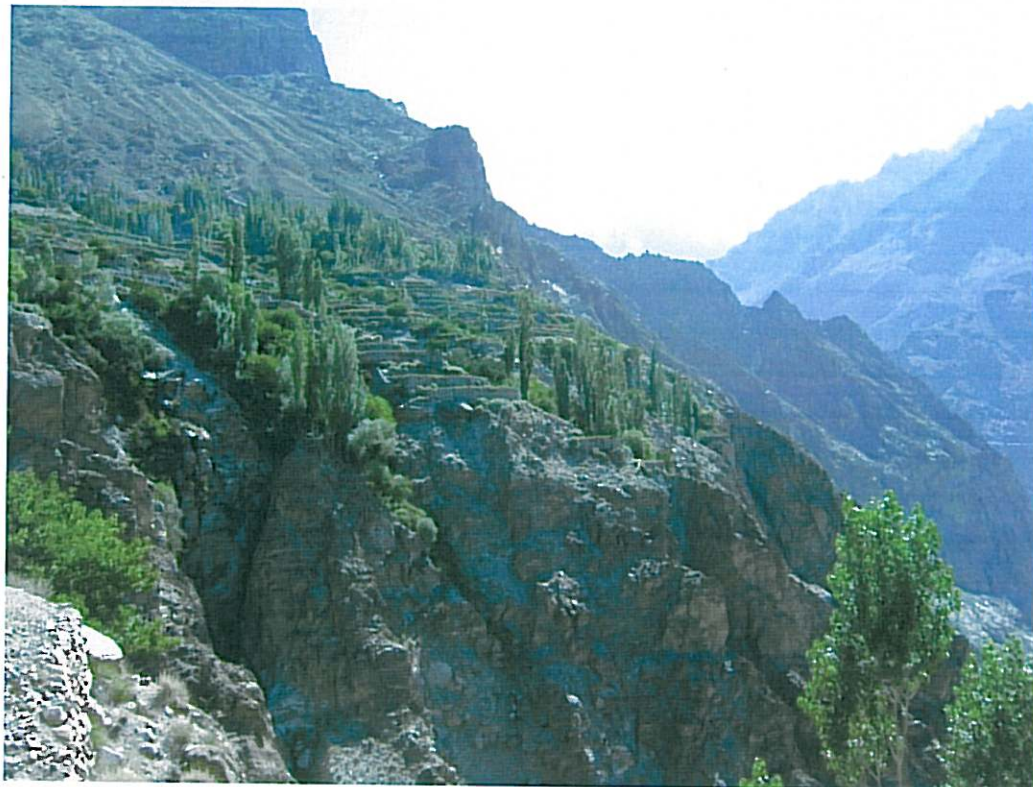
Figure 4.4: View of terraces, backslope and toe of Atta Abad village

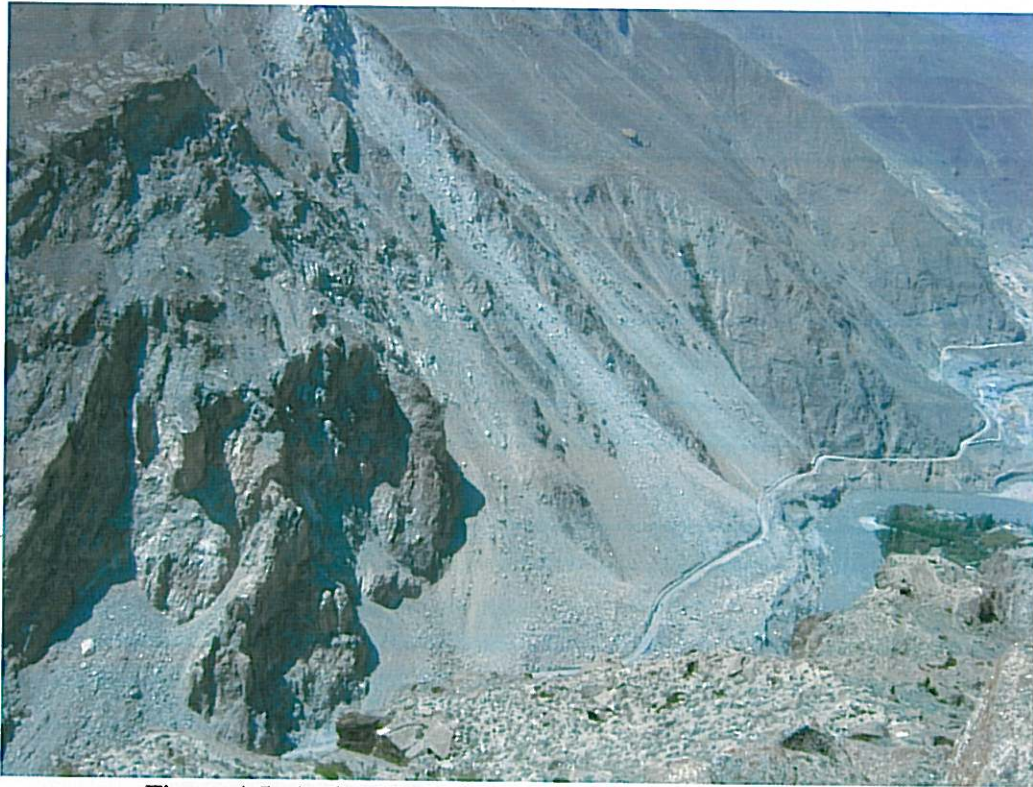
2. A fault is passing through the affected area having a strike NS and crossing the river. A huge landslide has developed across the river and timing of slope failure at Atta Abad and landslide across the river is quite same. This landslide is associated with the fault. The movement along this fault has weakened the shearing strength of the rocks and decreased the angle of repose in the area.

Figure 4.5: Active landslide across Hunza River, Atta Abad

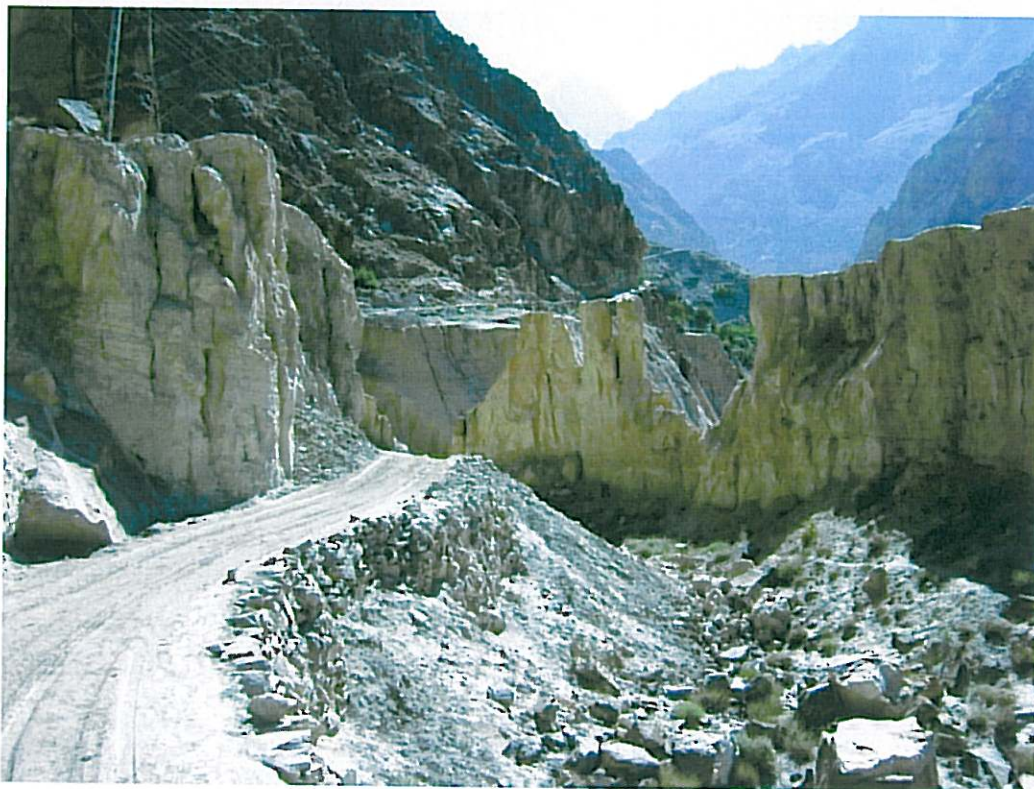
Figure 4.6: Lacustrine deposits near Atta Abad at village Sarat

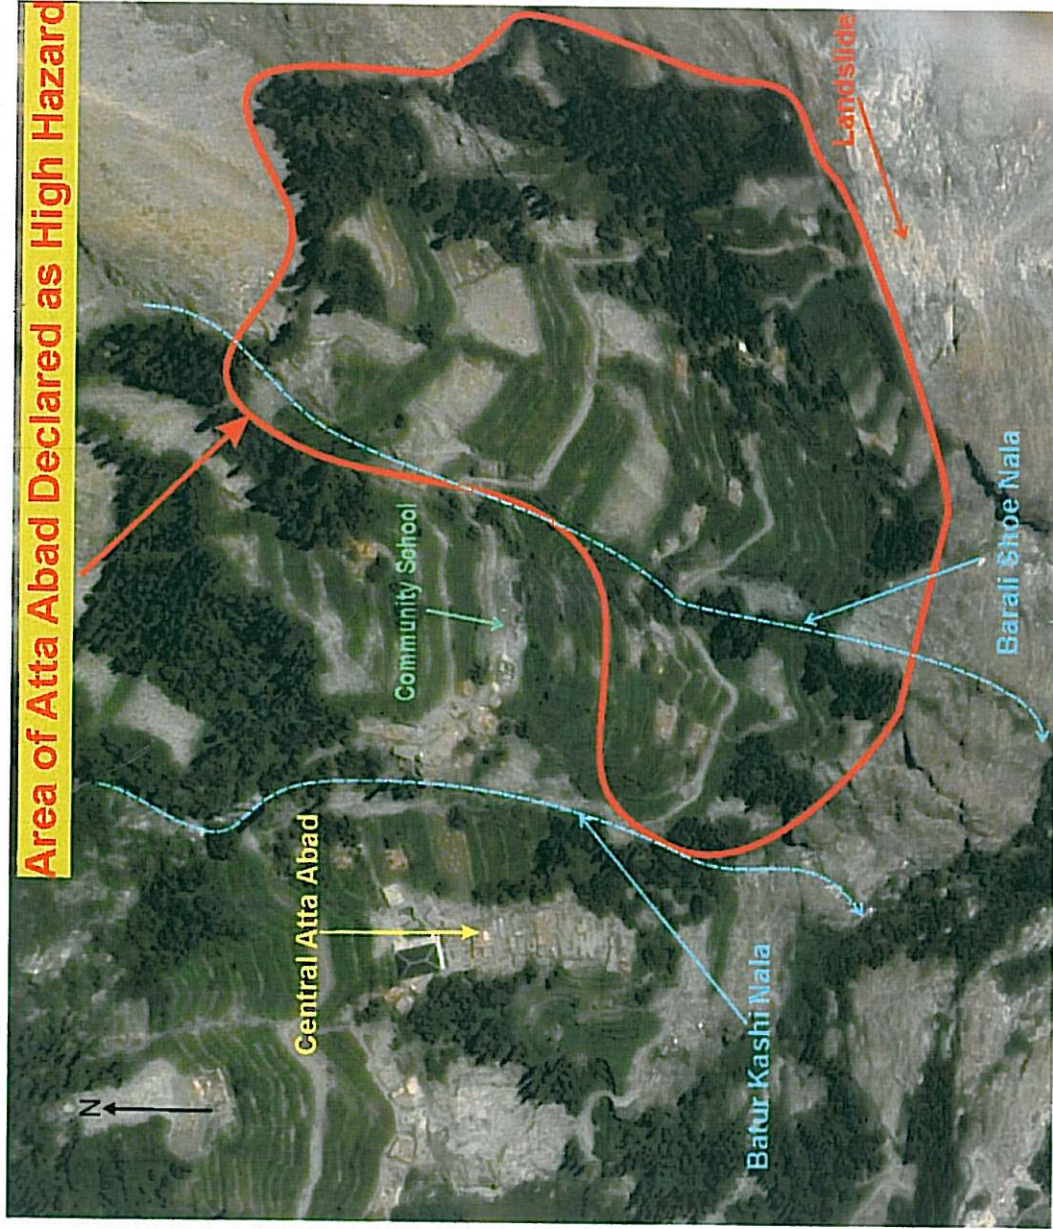
Based on the detailed Geological and Geotechnical survey carried out in the area, information collected from locals and authorities, the major portion of eastern part of Atta Abad is declared as High Hazard. The High Hazard area starts from the eastern most margins of Atta Abad and this area is locally known as part of Ghumrat. It is bounded by the half length (at coordinates 36 18 53.50 N & 74 48 55.30 E) of Barali Shoe Nala crossing the terraces. The line of High Hazard is extended parallel of the terraces to the Batur Kashi Nala and follows the Nala downslope. (Note: Boundaries of the High Hazard area demonstrated within the red line in Fig No.4.7).

Figure 4.7: Area of Atta Abad declared as High Hazard

1. The High Hazard area should be evacuated from the population immediately and the affected families should be compensated in the forms of alternate lands/others.
